RESOLUTION NO. 2950.24

A RESOLUTION OF THE TOWN COUNCIL OF THE TOWN OF GOLDEN BEACH, FLORIDA, AUTHORIZING AND APPROVING THE SCOPE OF WORK FROM MWI PUMPS FOR THE REPAIR OF THE STORMWATER PUMP AT SOUTH PARK IN AN AMOUNT NOT TO EXCEED \$25,859.96; PROVIDING FOR IMPLEMENTATION; AND PROVIDING FOR AN EFFECTIVE DATE.

Subject: **Resolution No. 2950.24 – Authorizing and Approving the scope of work for MWI Pumps to repair the stormwater pump at South Park.**

REF: Golden Beach Submersible Pump Repair

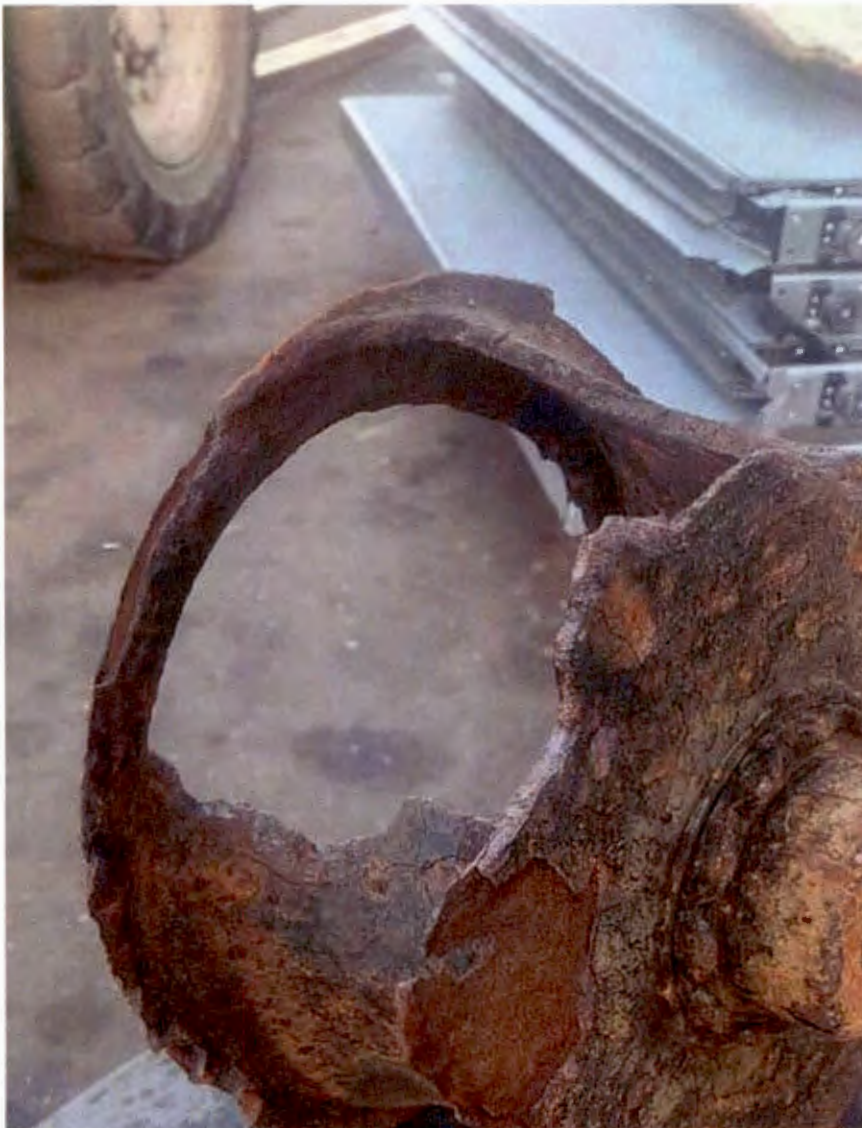
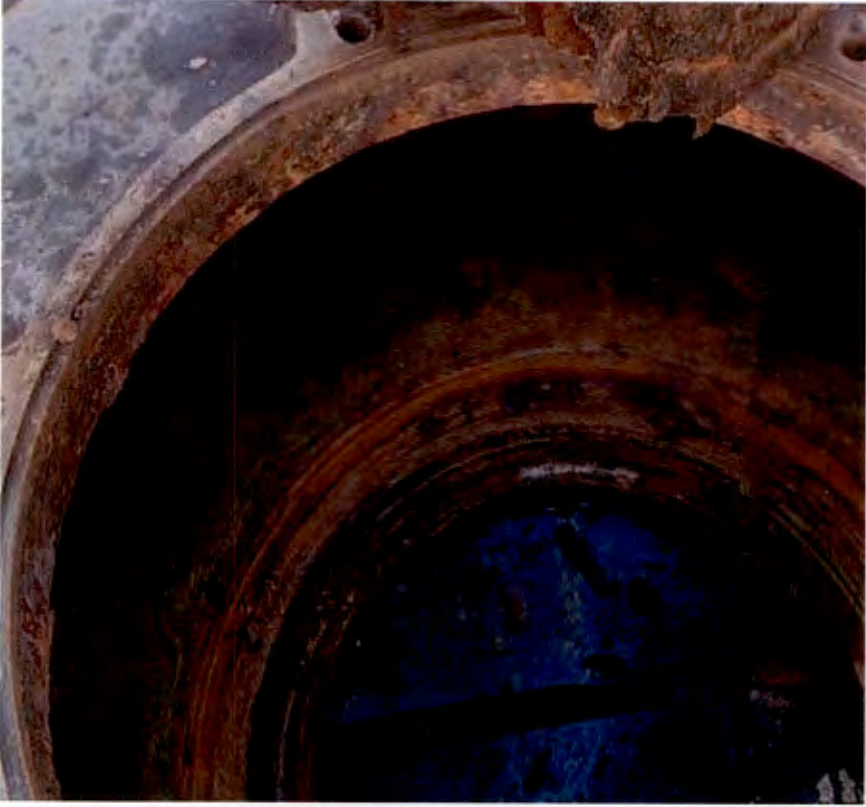
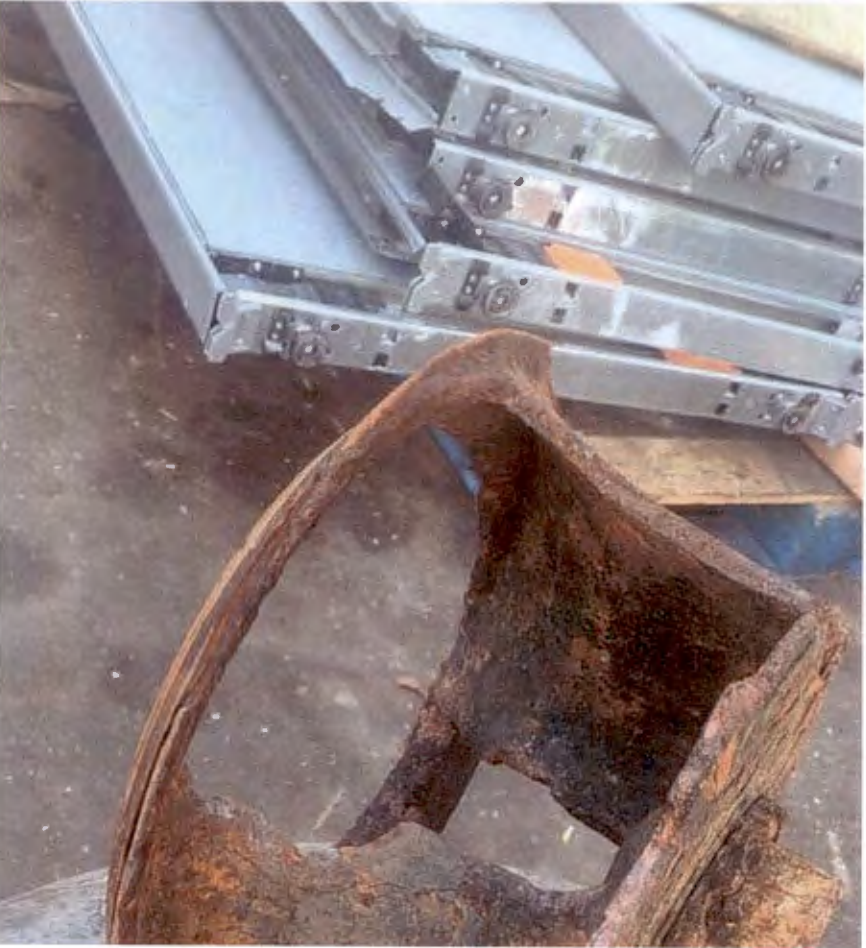
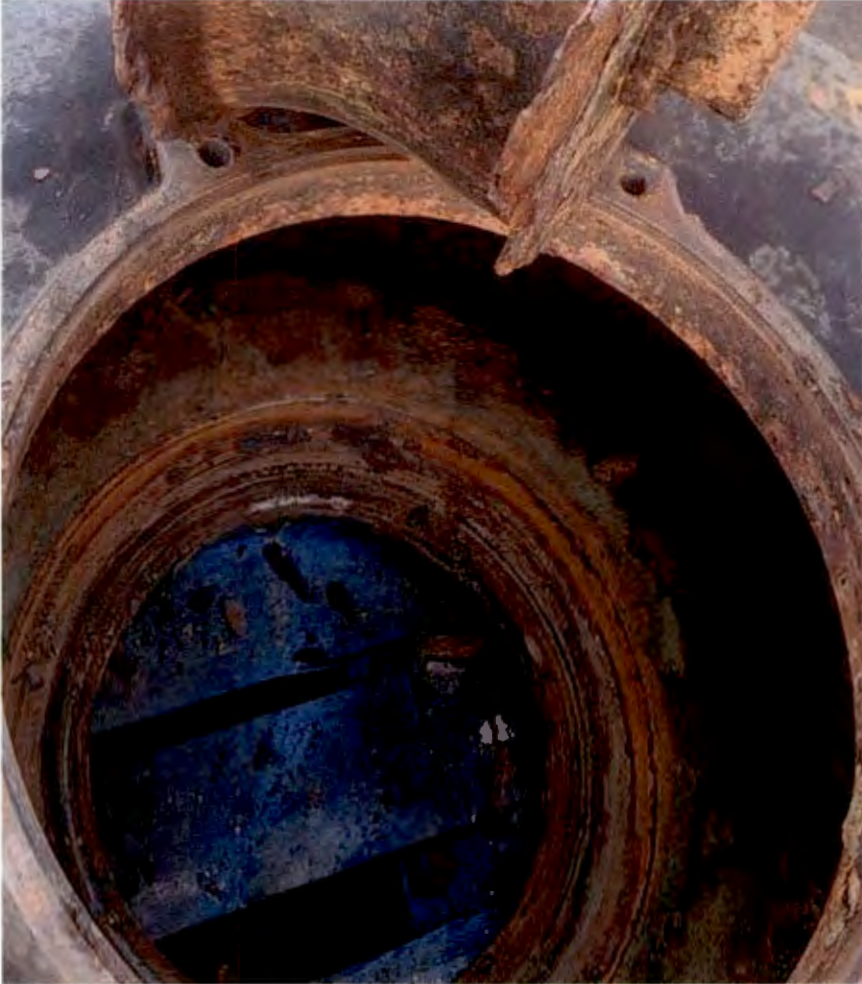
As part of our routine inspection and maintenance of our Stormwater System, it was discovered that one of the two Stormwater Pumps in South Park has reached the end of its useful life because of the amount of corrosion that has occurred. The repair will include the replacement of the impeller, shaft and bearings.

Attached please find the quote from MWI for the South Park Pump Repair. I have included a brochure on Belzona pump coatings. The pictures below indicate the salt water corrosion on the pump after being submerged for twenty years. The pump coating will extend the pump's lifespan. The cost is between \$1,000 to \$2,000. While the pump is in the shop, now would be the time to do it. Let me know your thoughts. If you want to just repair the pump, impeller, shaft and bearings please sign the MWI quote and return it to me. Thanks.

In addition, our engineers have recommended that we apply a coating that will extend the pump's lifespan. The cost is between \$1,000 to \$2,000 for the coating. The attached Exhibit A is a complete breakdown of all items for council review.

Disassemble pump, inspect all parts, clean and sandblast all parts, burn out stator, record data, rewind stator, double dip and bake.
Repair shaft end and make new keyway, metalize shaft on seal area.
Dynamically balance rotor with new impeller.
Furnish and install new seal kit with bearings and o rings, reassemble, fill with oil.
Paint and test.
New OEM impeller.

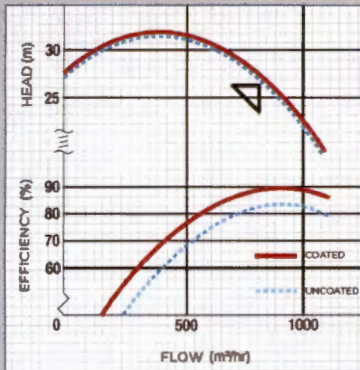
INDEPENDENT FLUID FLOW TEST BY THE BRITISH NATIONAL ENGINEERING LABORATORIES (N.E.L.):

For this test, a single stage, end suction centrifugal pump with 10 inch suction and discharge branches was chosen. In uncoated condition and running at 1300 rpm, the pump was found to deliver 875m³/hr at 26.5 meter head with an overall peak efficiency of 83.5%.

Testing of the same pump coated with Belzona 1341 (Supermetalglide) gave a 6% increase at peak efficiency, resulting in a power reduction of 5.1kW at duty point. Assuming a 5,000 hour operating cycle/annum, the power saving over this period would amount to 25,500kWhr.

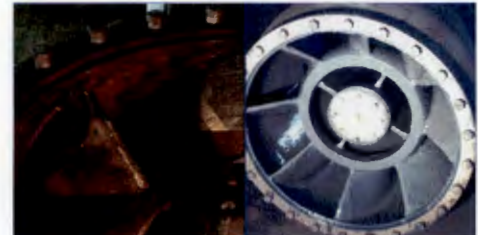
Diffuser vanes with steel gauze in place

Completed application

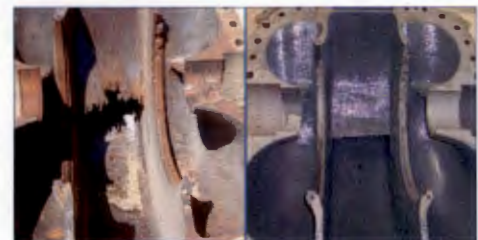
Typical effects of erosion-corrosion on a centrifugal pump cutwater

After rebuilding and coating with Belzona

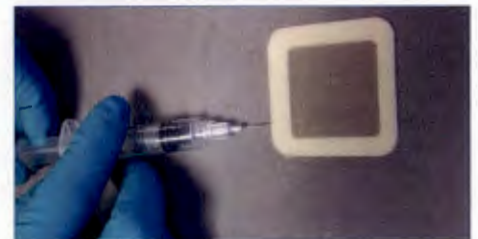
Thorough inspection for salt contamination (including chloride concentration measurement) ensures optimum surface preparation

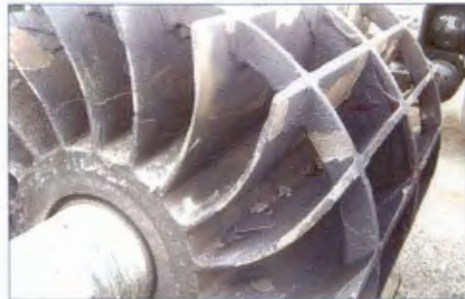
Damaged rotor before rebuilding

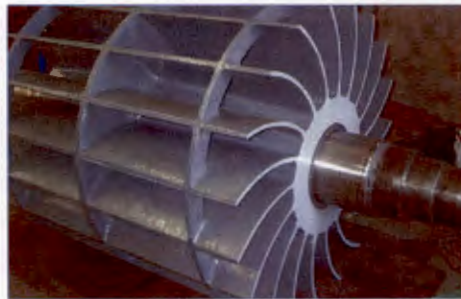
Application of Belzona 1311 and Belzona 1321

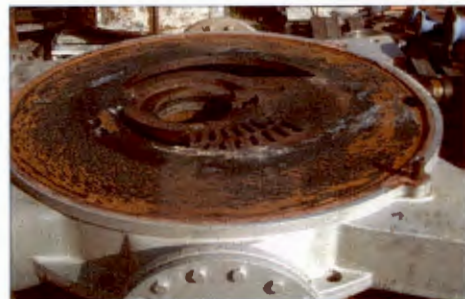
Erosion-corrosion damage on port plate

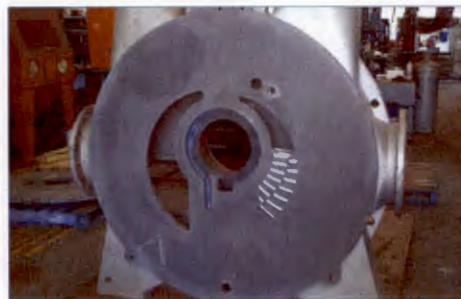
Port plate repaired with Belzona 1111

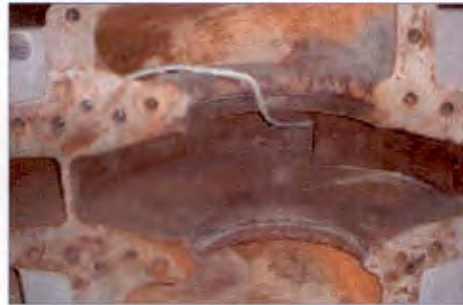
The water supply company in this example had to deal with a problem of two badly corroded/cavitated centrifugal KSB water supply pumps, whose output had drastically decreased by 11%. In addition to erosion caused by cavitation, general and bi-metallic corrosion had caused leakage at the wear rings, which contributed to the significant loss in efficiency.

Corroded and cavitated pump

It was decided to restore the neck ring seats by a forming technique, using the neck rings as formers. First, the interior of the cast iron pump was grit blasted to the required surface preparation standard and the neck rings treated with release agent so that they could later be removed. Next, **Belzona 1111 (Super Metal)** was gradually built up on the prepared neck ring area. Immediately afterwards, the impeller of the pump (including the released neck rings) was lowered into position and all excess Belzona material that exuded from beneath the forming surfaces was removed. Correct height and alignment of the forming part is ensured by the correctly mounted and positioned bearings.

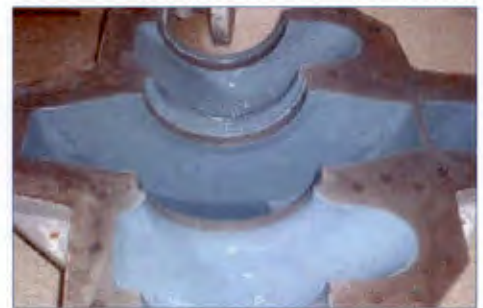
Completed repair

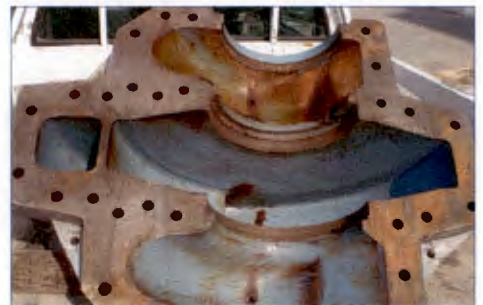
3½ years after the application, the pump was inspected and the flow rate was still found to be 530 l/sec, an increase of more than 9.5% over the corroded pump. ■

Coating in good condition after 3 ½ years in service
